**Atmospheric Infrared Sounder**

# AIRS and Aqua Mission Operations Status and New AIRS On-board Gain Table

**Denis Elliott**

**November 11, 2011**

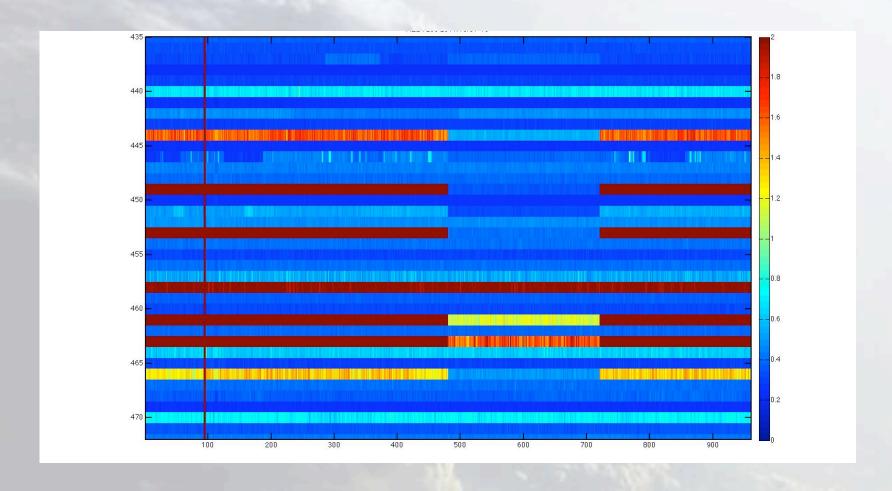
## Channel Ne∆T October 7–10 2011

- Exposure to radiation over the life of the mission has caused about 200 channels (out of 2378) to become noisier than specifications
- These channels are not "dead"—just noisier than we would like
- The rate of detectors changing noise behavior has increased in parallel with solar activity
- AIRS guard tests are used to identify whether it is the A detector or B detector or both that are at fault
- If just the A or just the B is noisy, the channel can be restored to in-spec performance by setting the gain of the noisy detector to 0

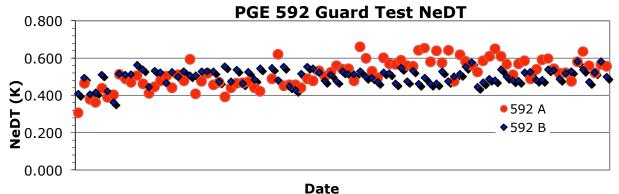
# Slightly worse Channel 592, A+B -> B

Result: NEDT 0.36 -> 0.45, no apparent improvement in stability.

Rationale: improve stability
